Case 266 : Narrative

Case Vehicle (A): 2000 Ford
Type: Ranger Supercab XLT, 4x4 pickup
Driver: 17-year-old male
CDC: 12-FLEW-3, 00-RDAO-2

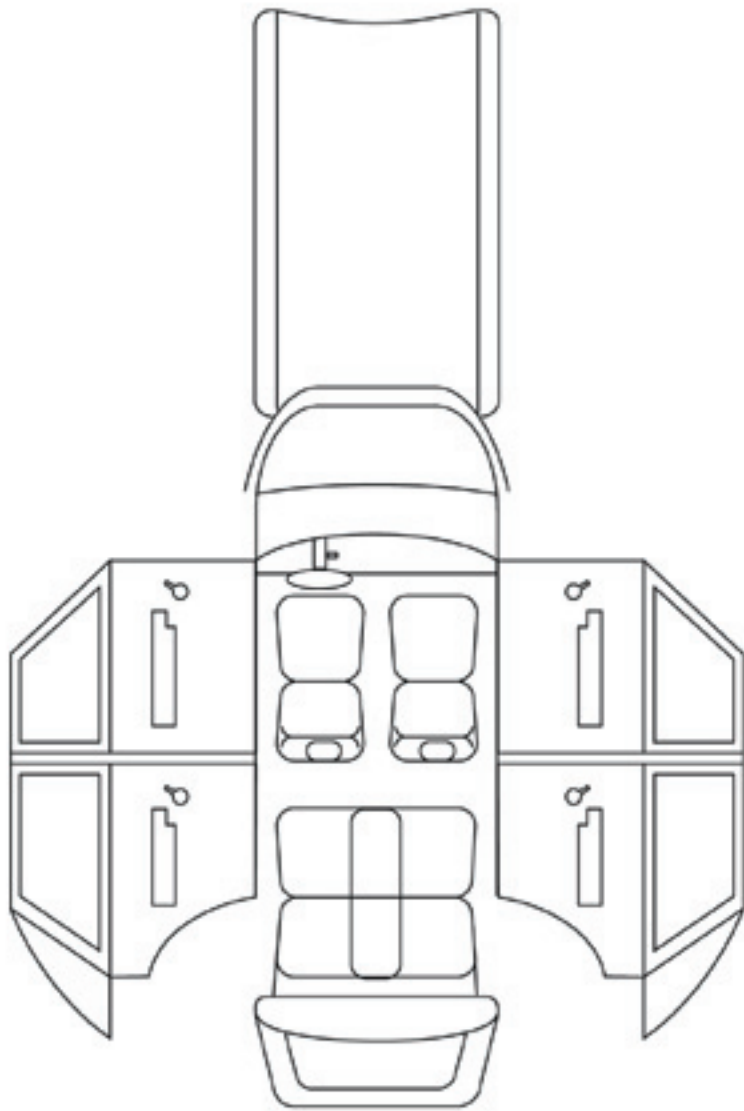
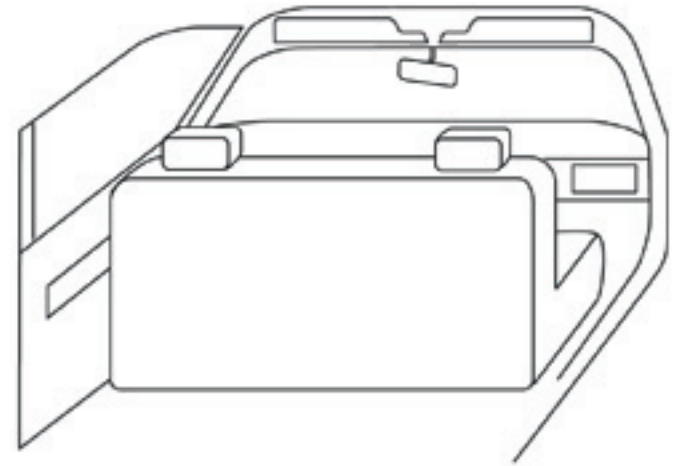
OCCUPANT CONTACT WORKSHEET

no evidence of driver belt use

A: windshield
(4-cm crack in glass, grease mark)

C: driver-side sunvisor
(3-cm scuff mark)
